## Site 417 Island Road II

Great Marsh Coastal Wetlands Restoration Plan  
Rapid Technical Assessment Site 417

Site # 417  
Island Road II

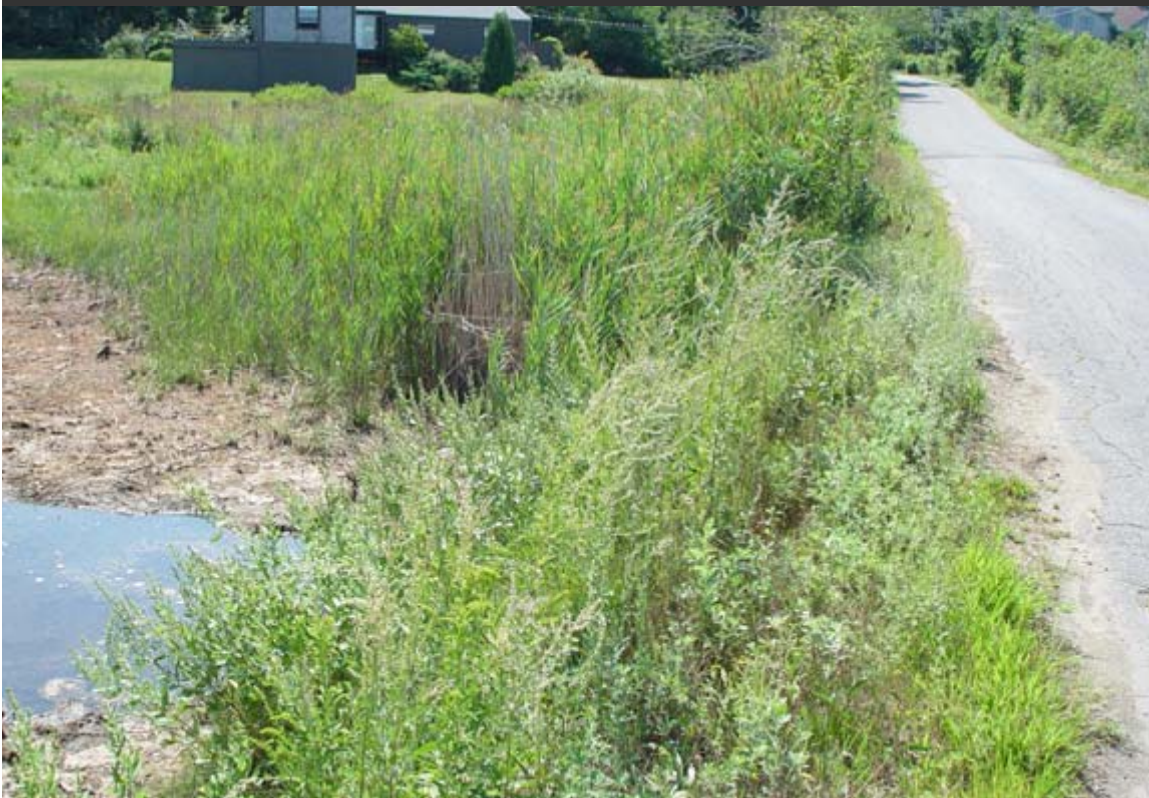
**Photo 3 - View of Downstream Salt Marsh West of Island Road**

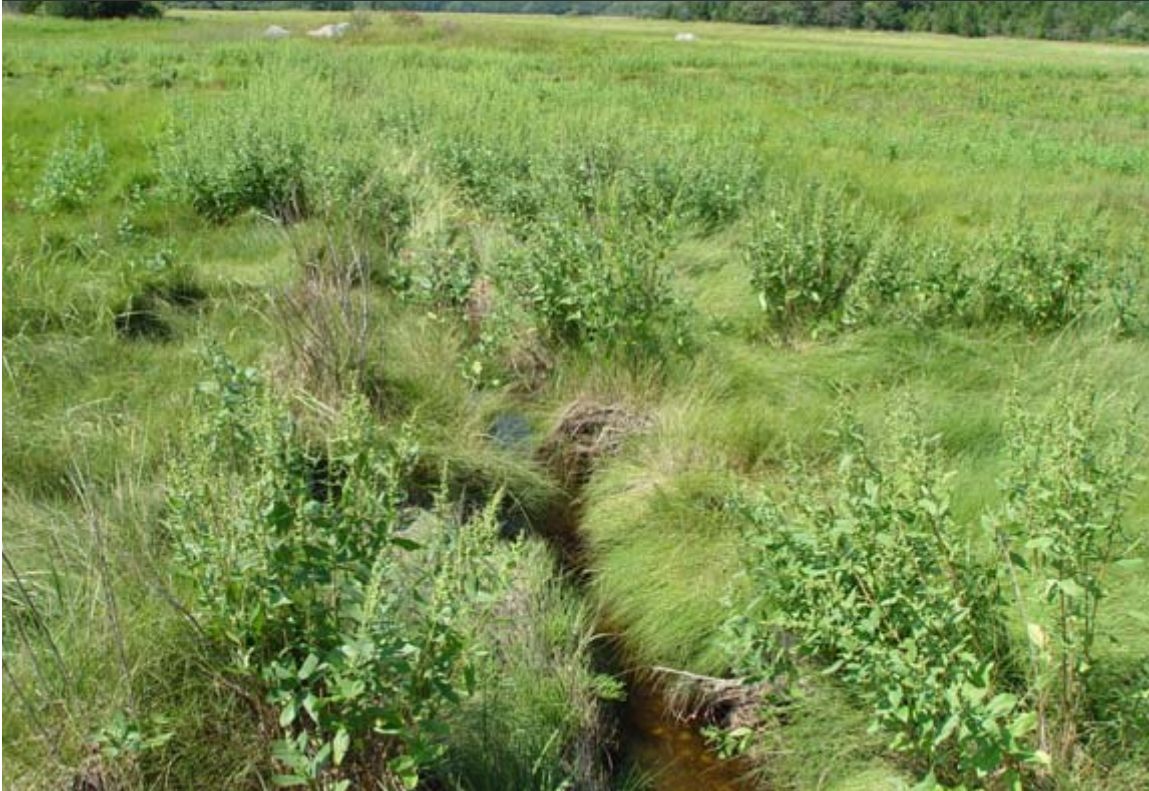
**Photo 4 - Overview of Restoration Area Viewing North**

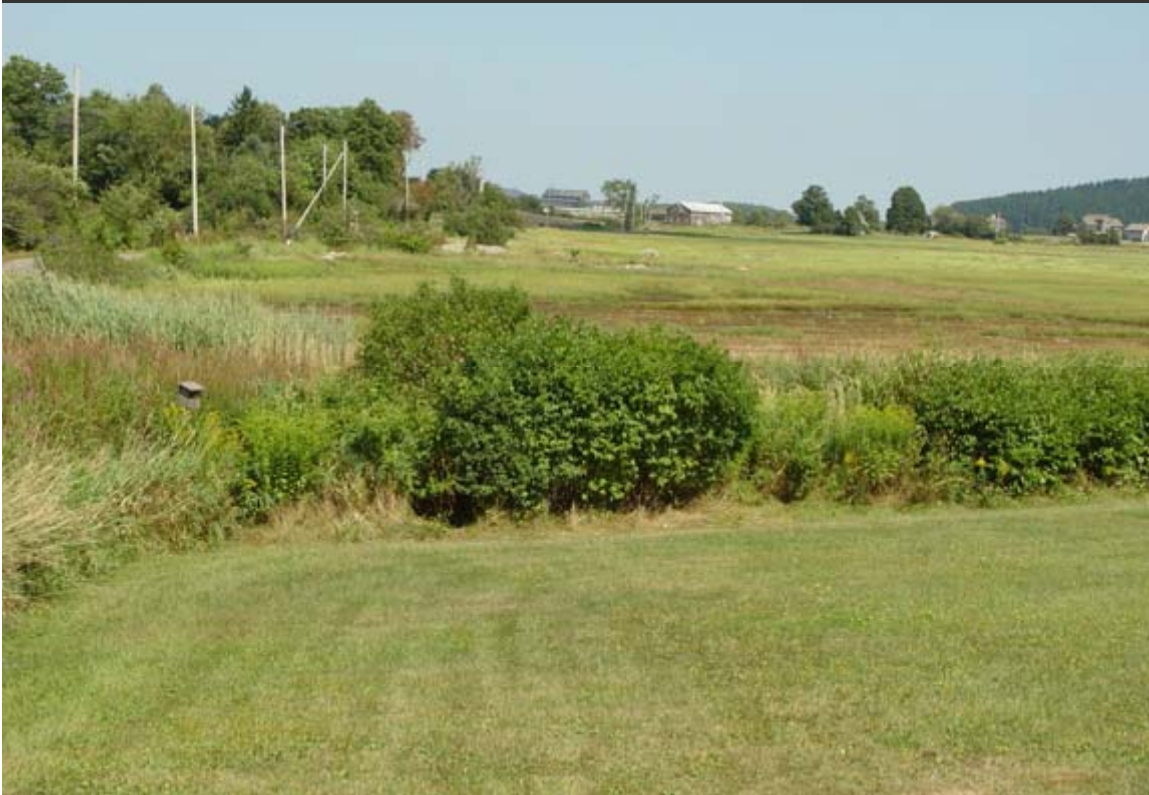
**Photo 5 - View of Restoration Area from Old Farm Road**
